PRE-RENOVATION ASBESTOS AND HAZARDOUS MATERIALS SURVEY

PREPARED FOR Tetra Tech, Inc.
1 South Wacker Drive, 37th Floor
Chicago, Illinois 60606

PROJECT # 3010f2-2-194

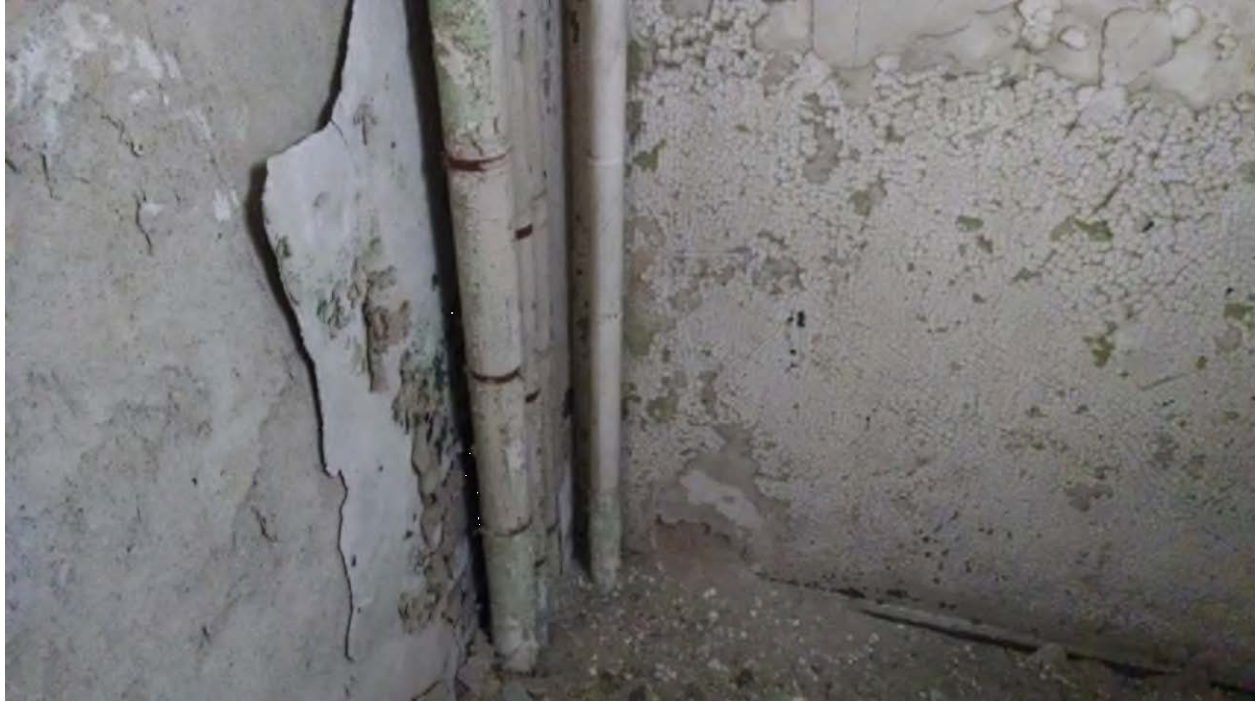
PHOTOGRAPH NO. 1: THERMAL SYSTEM INSULATION ACM (TYPICAL)

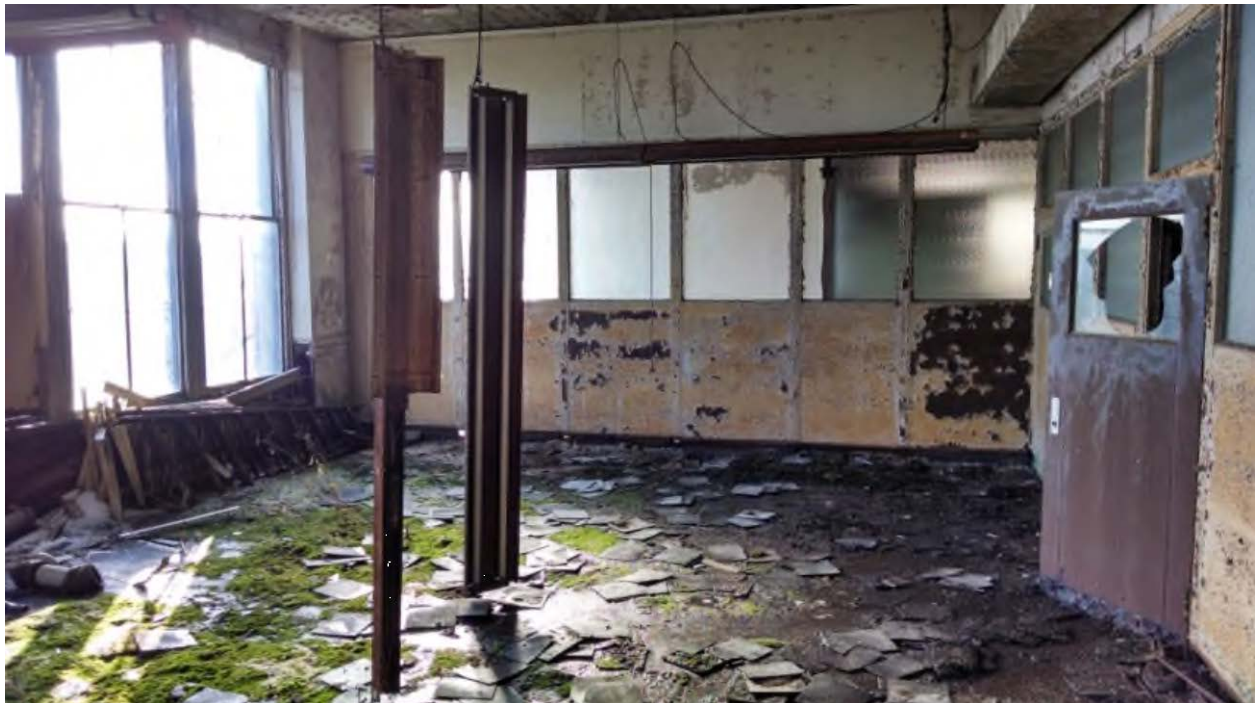
PHOTOGRAPH NO. 2: WINDOW CAULK AND FLOOR TILE AREAS (TYPICAL)

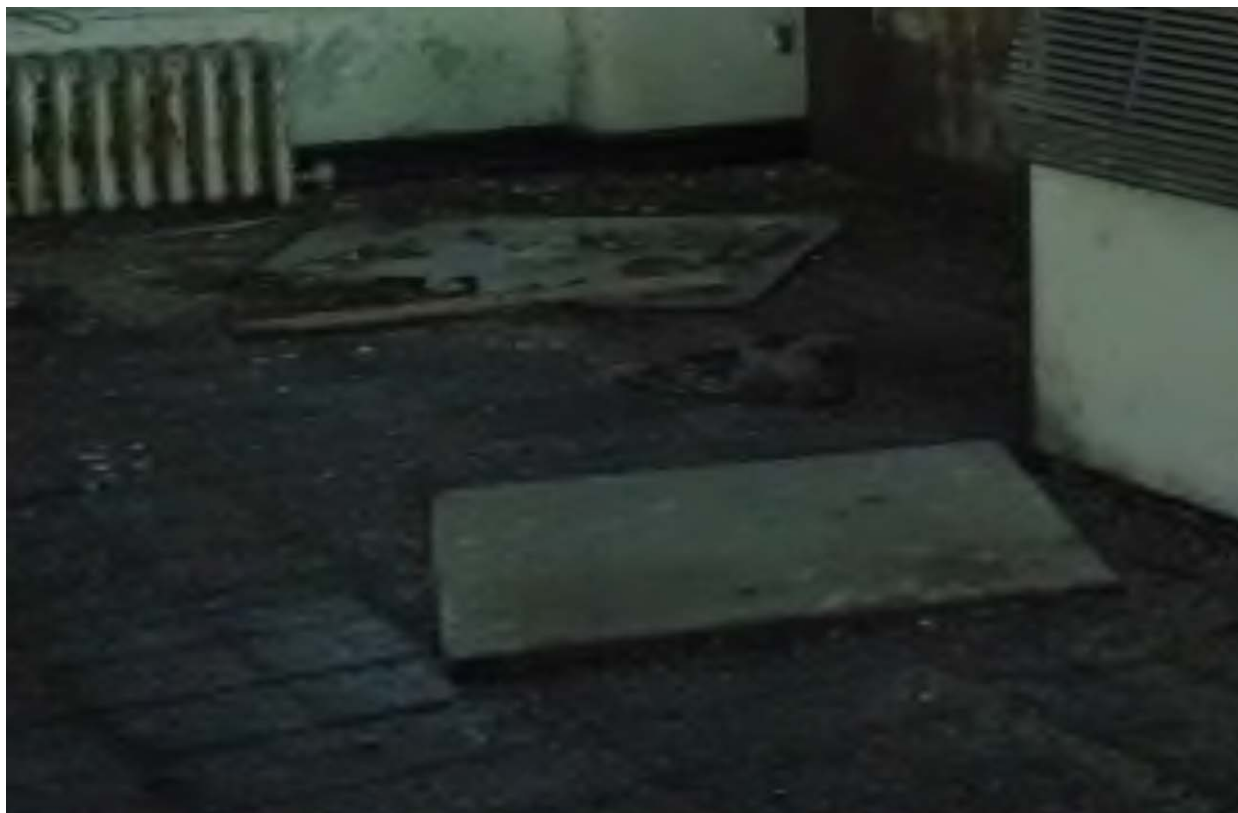
PHOTOGRAPH NO. 3: FLOOR TILE ACM (TYPICAL)

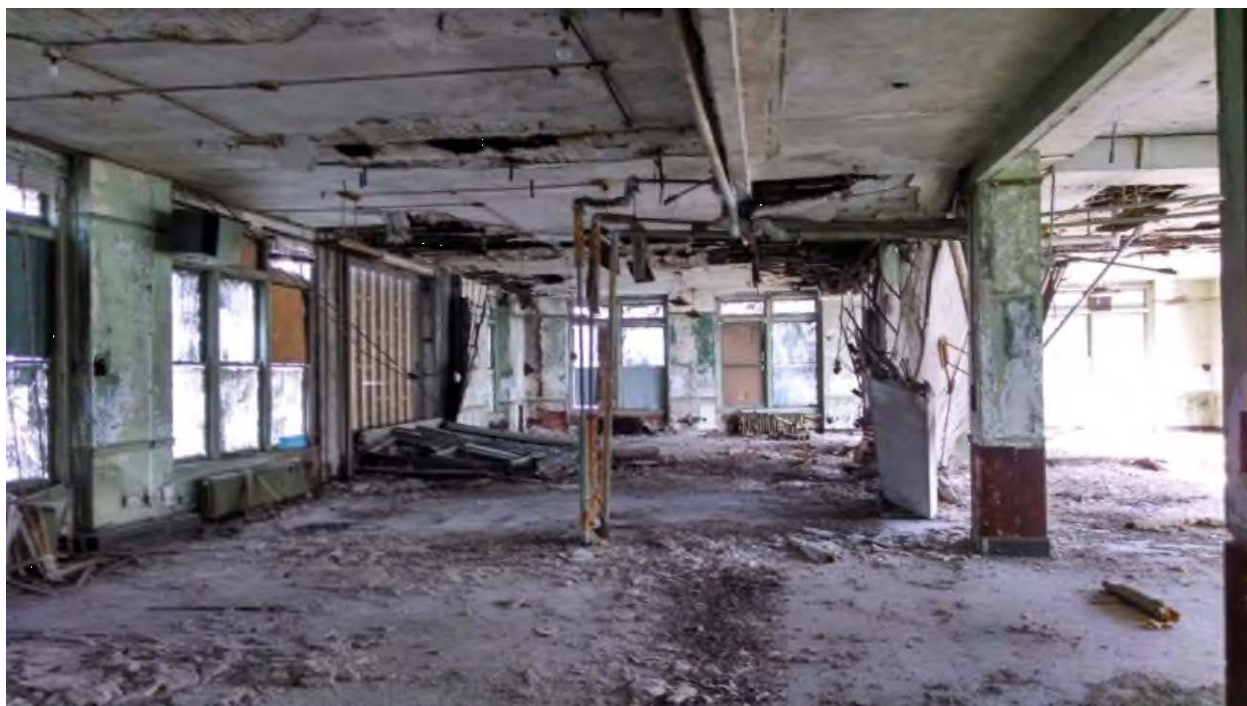
PHOTOGRAPH NO. 4: WINDOW CAULK, THERMAL SYSTEM INSULATION AND FLOOR TILE ACM AREA (TYPICAL)
